# Mechanical Test Report

Equipment under      **D3313-S (D3313-S22)**  
Test (EUT):

Document No.:        MEC+1SB13-0020+M02

Test date:            January 27, until January 29, 2014

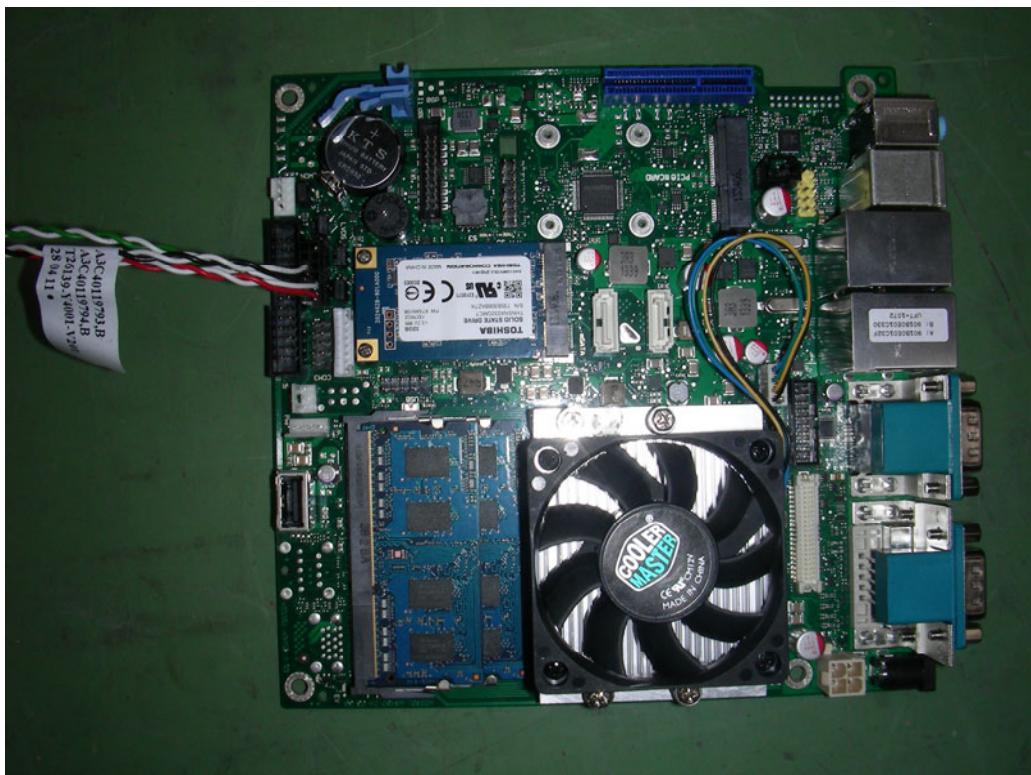
Picture no. 1: Top side of EUT

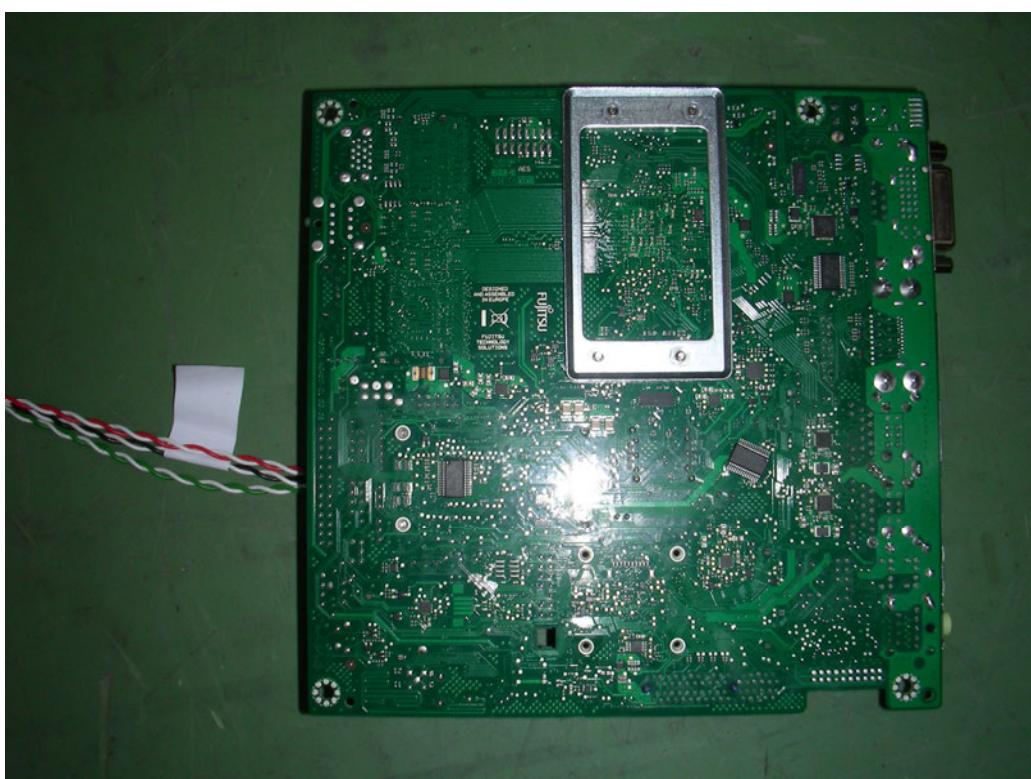
Picture no. 2: Bottom side of EUT
